**FIELD OVERSIGHT SUMMARY REPORT
ACS NPL SITE
GRIFFITH, INDIANA**

November 8, 1999

BLACK & VEATCH
SPECIAL PROJECTS CORP.

USEPA/ARCS V
BVSPC Oversight Summary

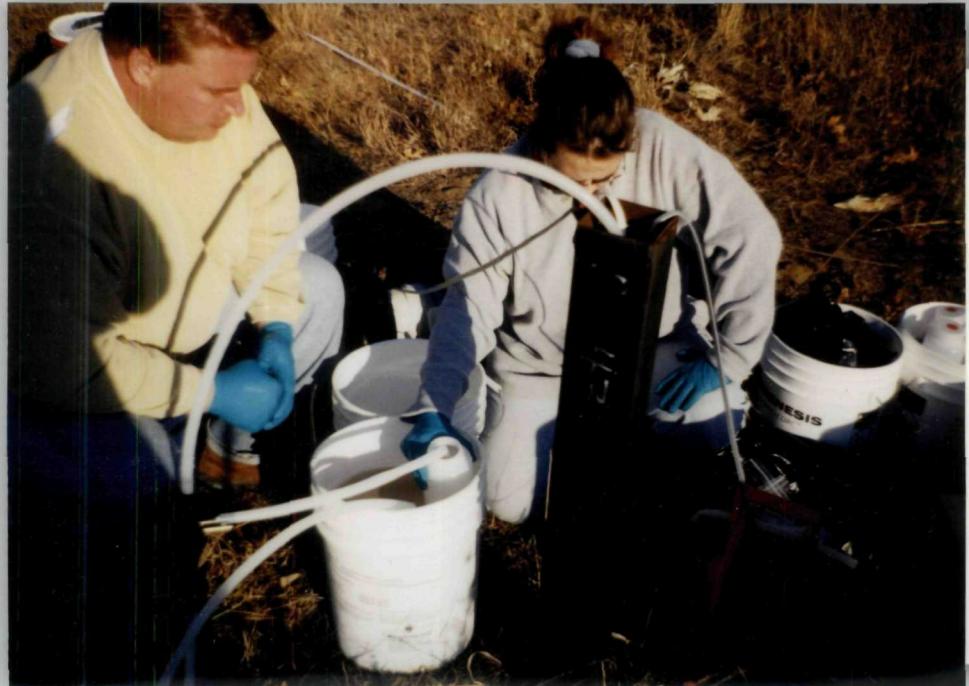
Site: American Chemical Services, Inc.
Proj. #: 46517/46518
Roll: 1 Photo #:15
Date: 11-09-99 Time: 08:27
Photographer: Chad Gailey
Description: Photo facing north at MW47 of Dawn Dougher filling a poly for metals analysis.

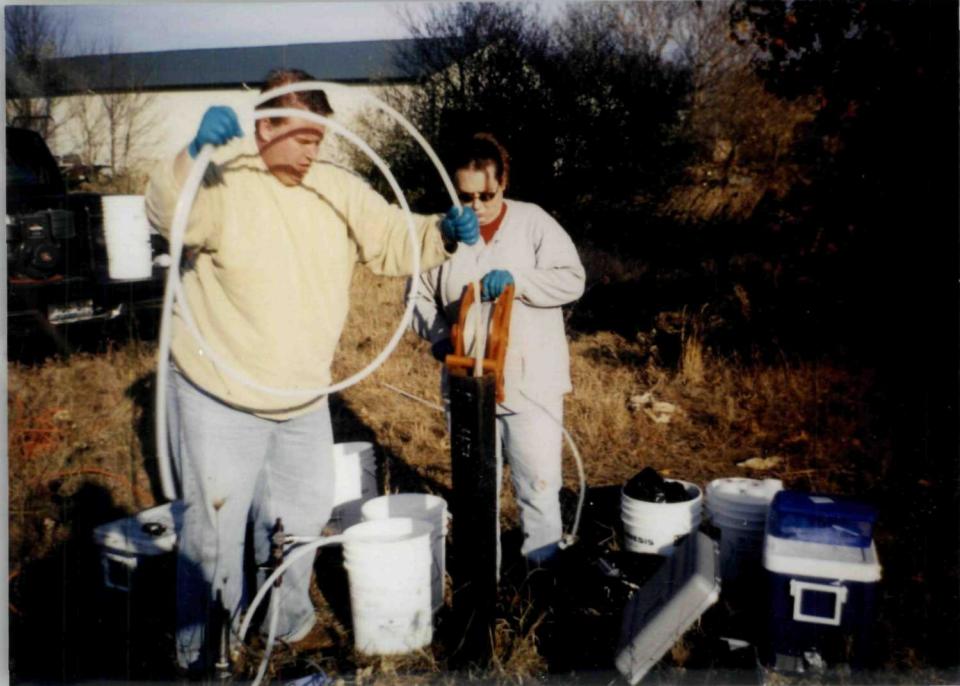
Site: American Chemical Services, Inc.
Proj. #: 46517/46518
Roll: 1 Photo #:16
Date: 11-09-99 Time: 08:30
Photographer: Chad Gailey
Description: Photo facing northwest at MW47 of Dawn Dougher and Rudy Stein pull out the sampling pump.

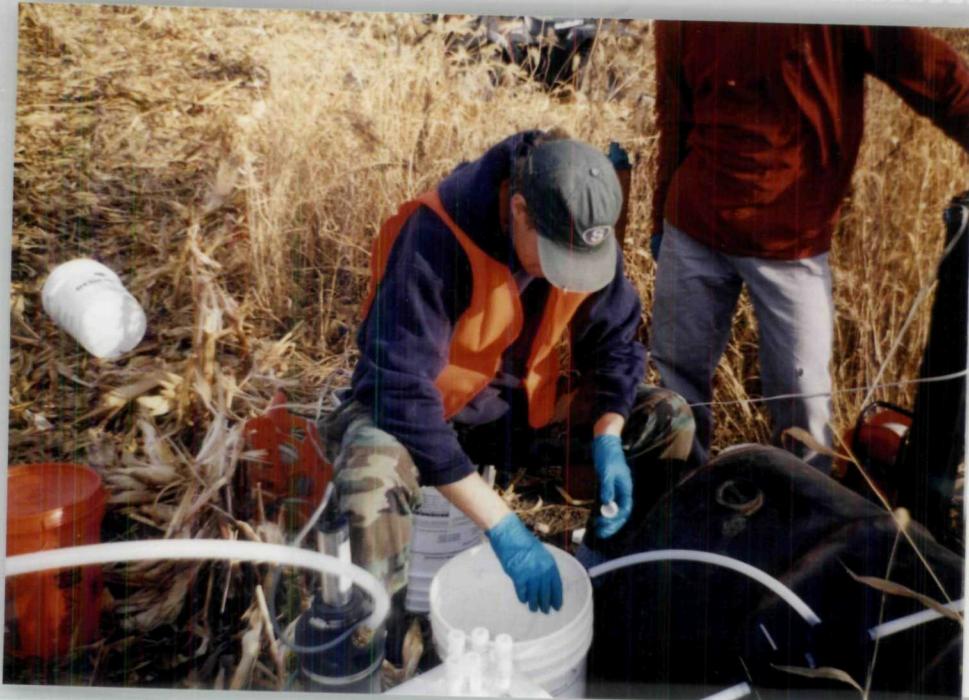
Site: American Chemical Services, Inc.
Proj. #: 46517/46518
Roll: 1 Photo #:17
Date: 11-09-99 Time: 09:00
Photographer: Chad Gailey
Description: Photo facing northeast at MW45
of Alex Ellwood filling a VOA
for indicator parameters.

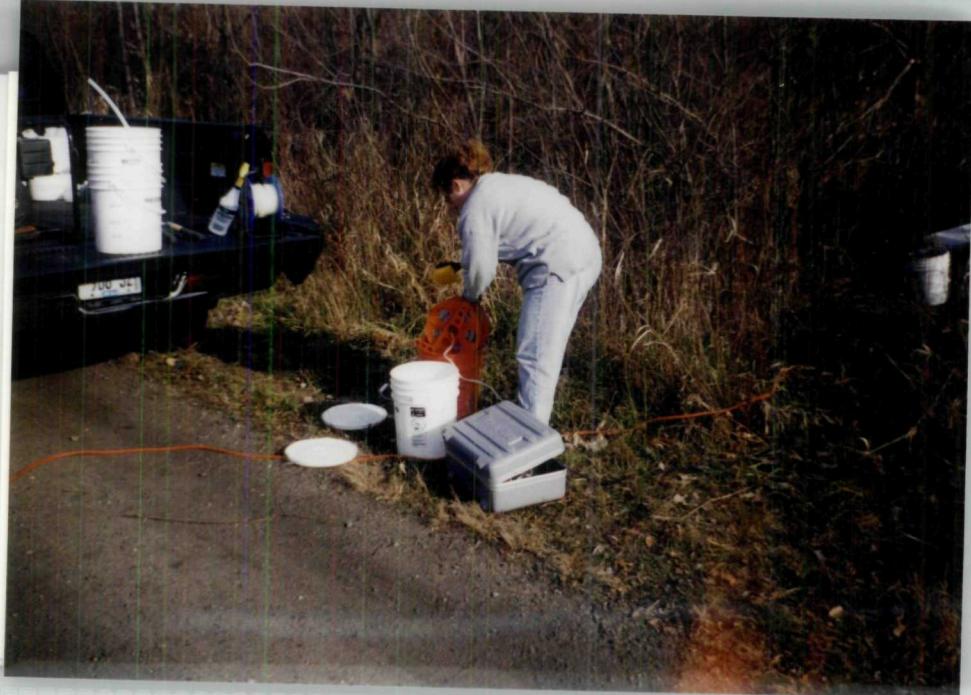
Site: American Chemical Services, Inc.
Proj. #: 46517/46518
Roll: 2 Photo #:1
Date: 11-09-99 Time: 09:35
Photographer: Chad Gailey
Description: Photo facing west at MW15 of
Dawn Dougher deconnning the
sampling equipment.

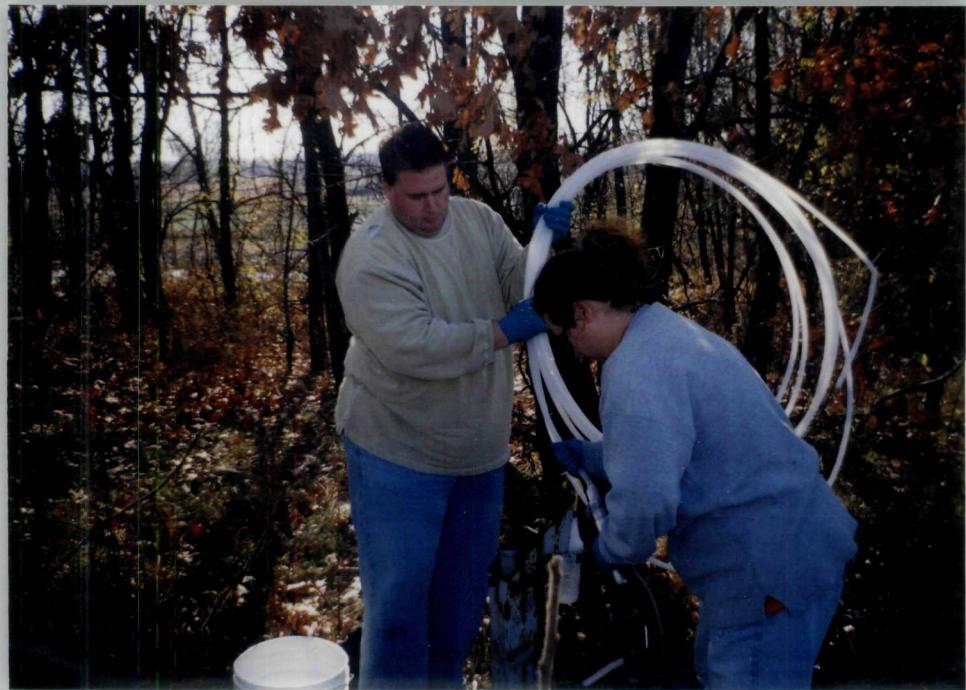
Site: American Chemical Services, Inc.
Proj. #: 46517/46518
Roll: 2 Photo #:3
Date: 11-09-99 Time: 09:53
Photographer: Chad Gailey
Description: Photo facing southwest at MW50
of Dawn Dougher and Rudy Stein
installing the sampling pump.

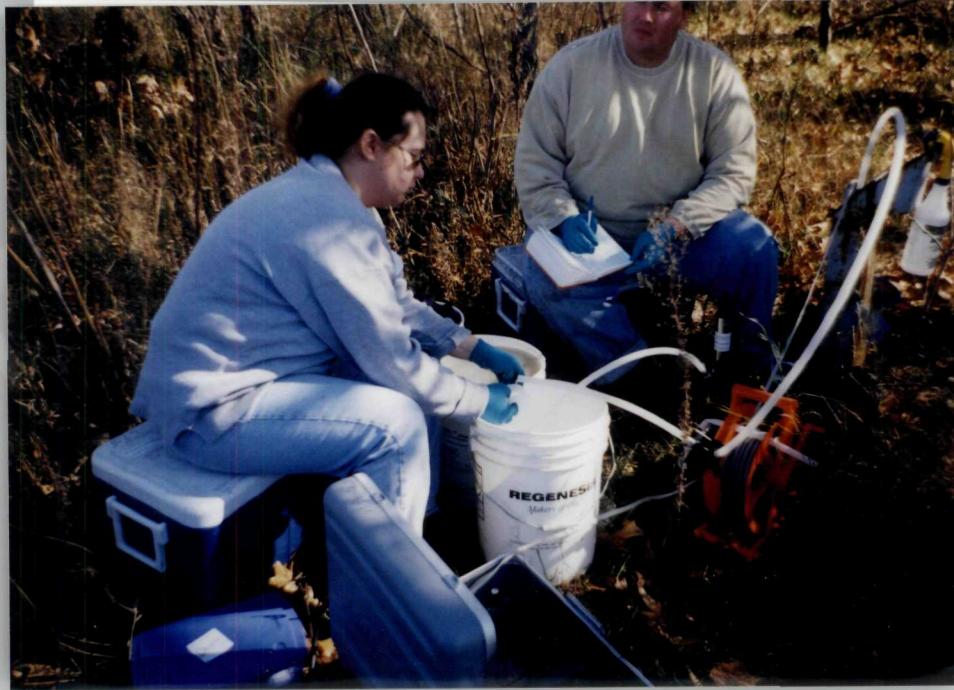
Site: American Chemical Services, Inc.
Proj. #: 46517/46518
Roll: 2 Photo #:4
Date: 11-09-99 Time: 10:37
Photographer: Chad Gailey
Description: Photo facing northeast at MW50
of Dawn Dougher fill a metals
poly for indicator parameters.

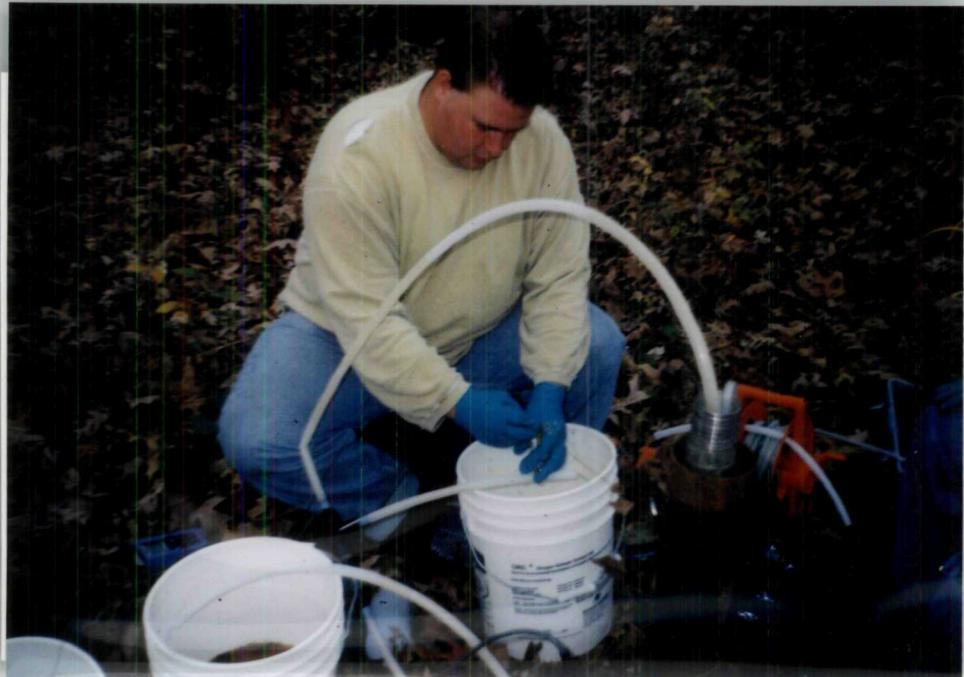
Description: Photo facing west inside the water treatment Bld. of Chad Smith pulling a equipment field blank.

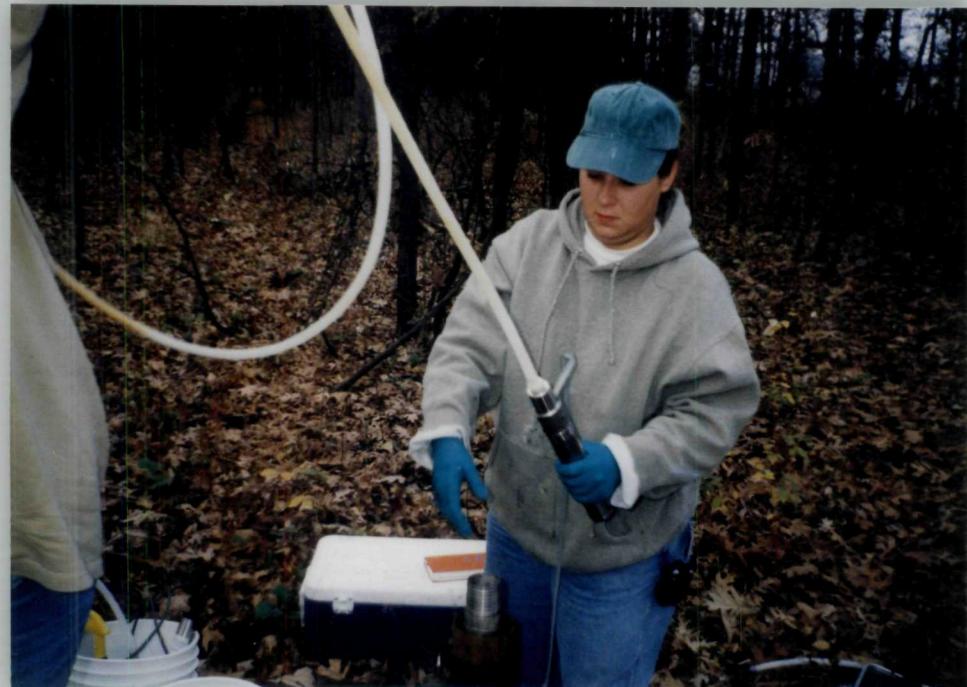
Site: American Chemical Services, Inc.
Proj. #: 46517/46518
Roll: 2 Photo #:7
Date: 11-10-99 Time: 08:05
Photographer: Chad Gailey
Description: Photo facing south at MW11 of Dawn Dougher and Rudy Stein extraction the sampling pump.

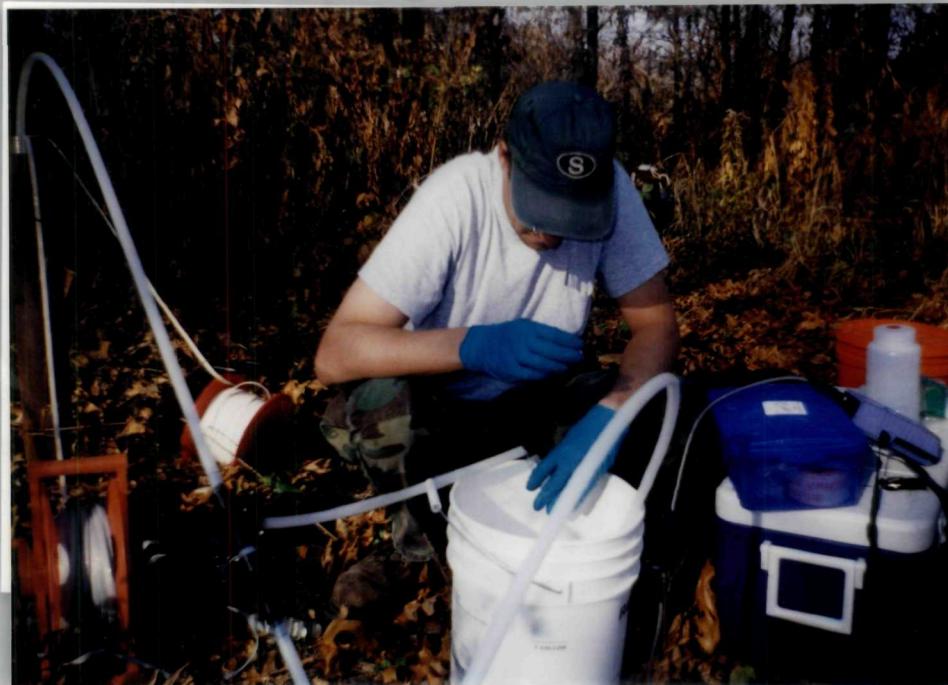
Site: American Chemical Services, Inc.
Proj. #: 46517/46518
Roll: 2 Photo #:8
Date: 11-10-99 Time: 09:38
Photographer: Chad Gailey
Description: Photo facing west at MW14 of Alex Ellwood fill a VOA for indicator parameters.

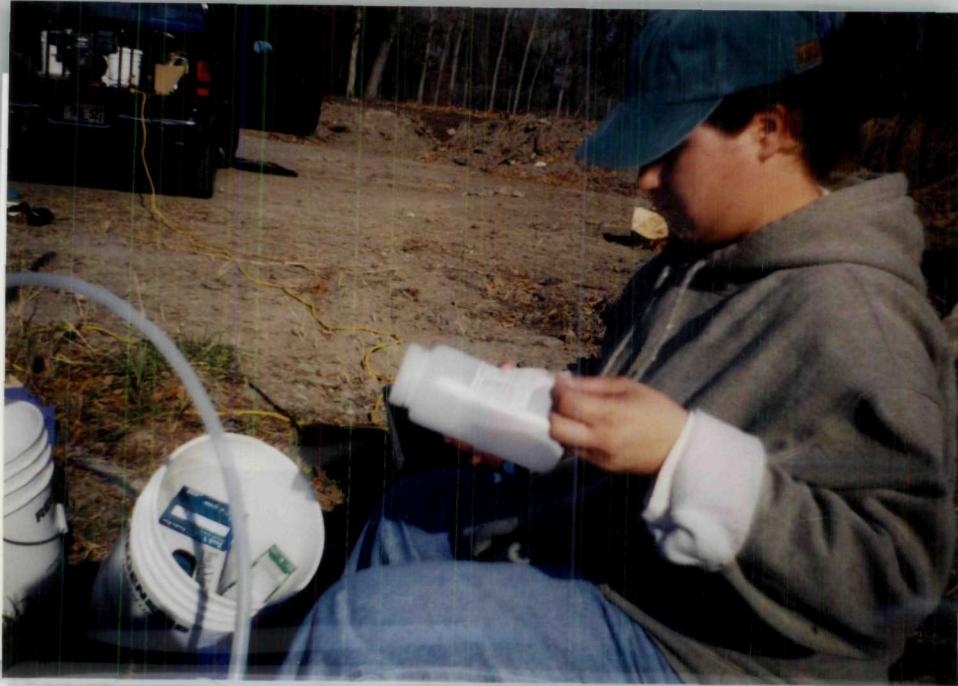
Description: Photo facing west at MW14 of
Alex Ellwood and Chad Smith
pulling out the sampling pump.

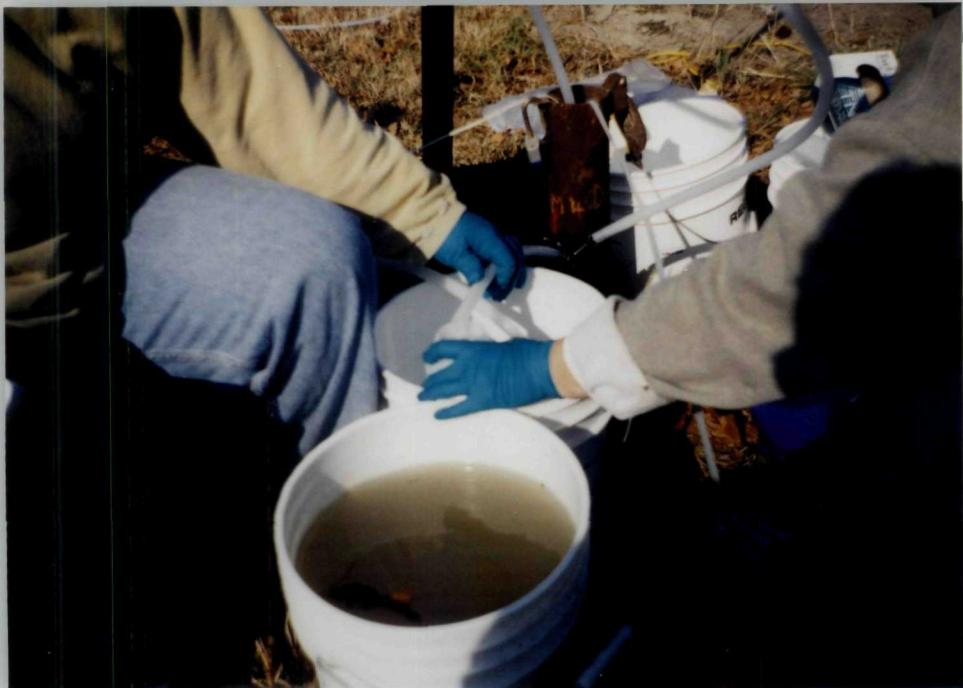
Site: American Chemical Services, Inc.
Proj. #: 46517/46518
Roll: 2 Photo #:11
Date: 11-10-99 Time: 10:36
Photographer: Chad Gailey
Description: Photo facing northeast at MD4 of Dawn Dougher and Rudy Stein filling a metals container for indicator parameters.

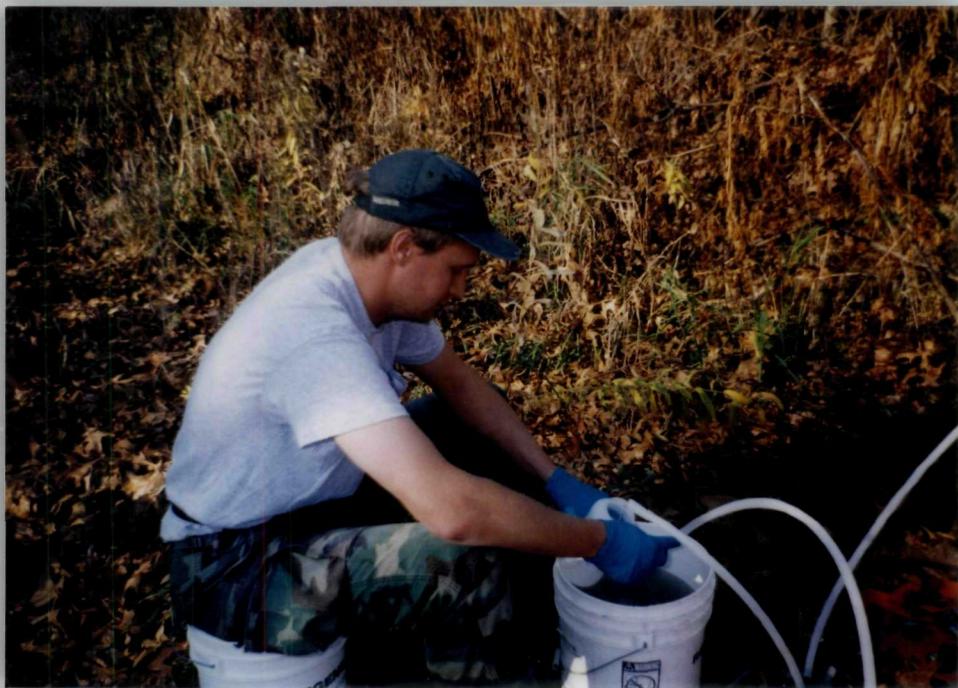
Site: American Chemical Services, Inc.
Proj. #: 46517/46518
Roll: 2 Photo #:12
Date: 11-10-99 Time: 11:22
Photographer: Chad Gailey
Description: Photo facing west at MW29 of Alex Ellwood filling a metals poly for indicator parameters.

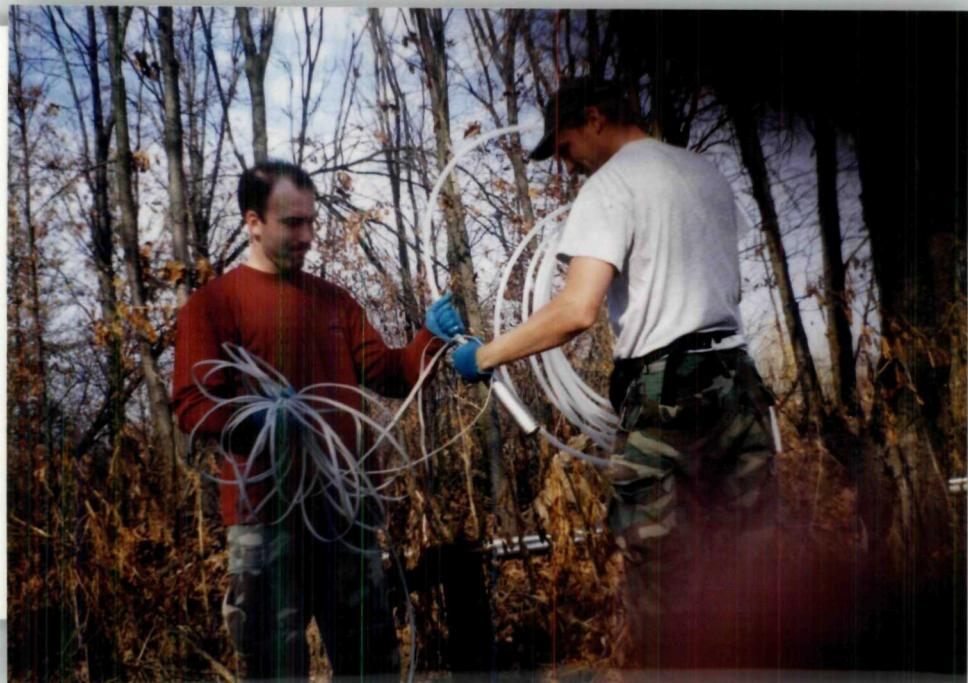
Description: Photo facing west at MW29 of
Chad Smith and Alex Ellwood
disconnection the pump after
sampling.

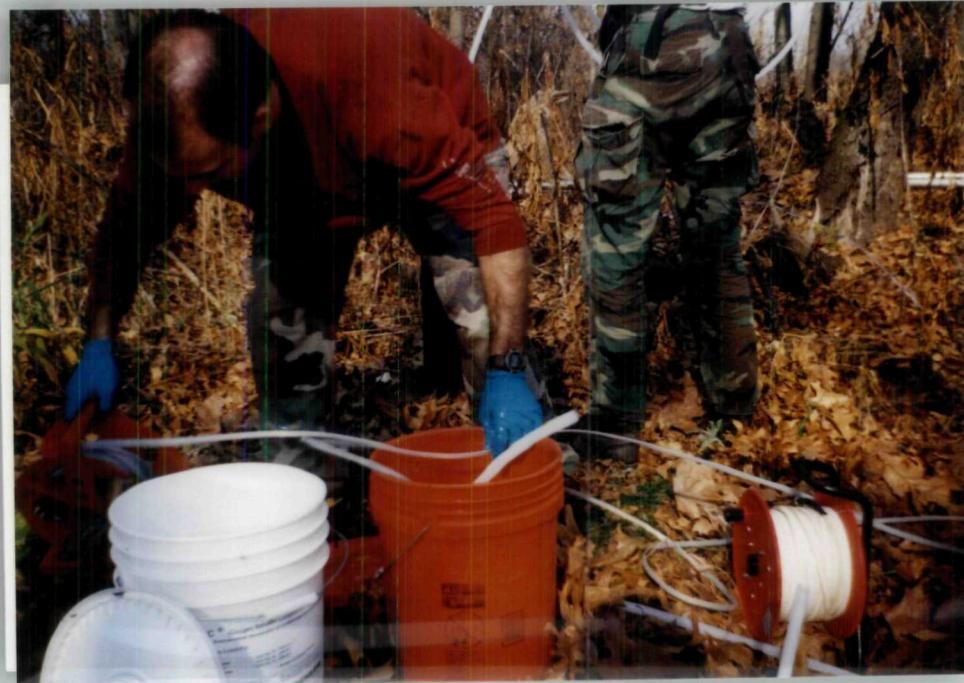
Description: Photo facing west at MW29 of
Chad Deconning the pump
controller cable.

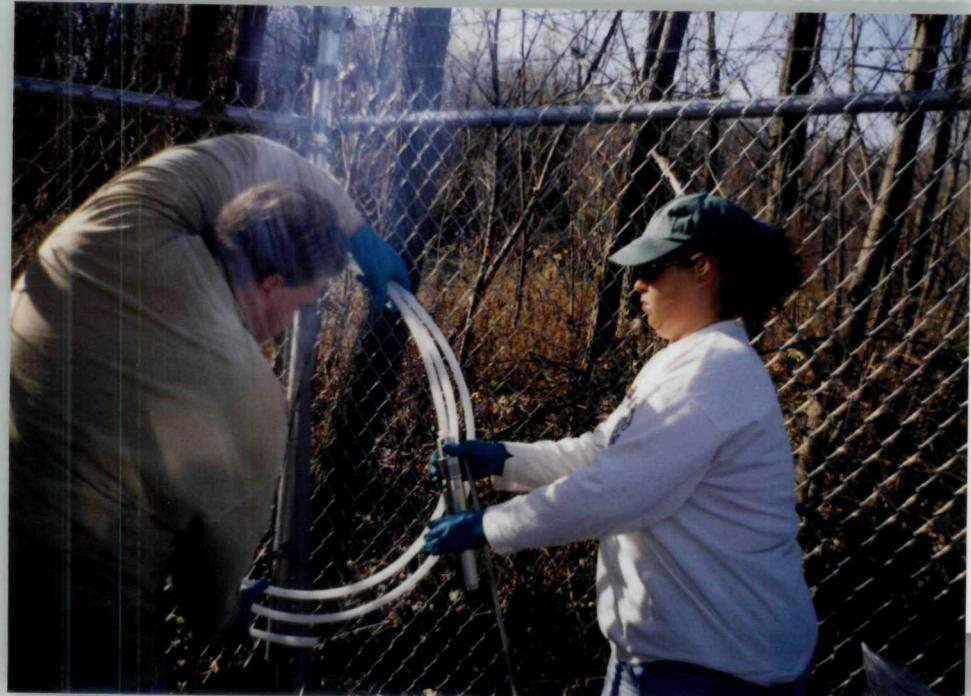
Site: American Chemical Services, Inc.
Proj. #: 46517/46518
Roll: 2 Photo #:15
Date: 11-10-99 Time: 13:50
Photographer: Chad Gailey
Description: Photo facing west at M1S of
Rudy Stein and Dawn Dougher
pulling out the pump after
sampling..

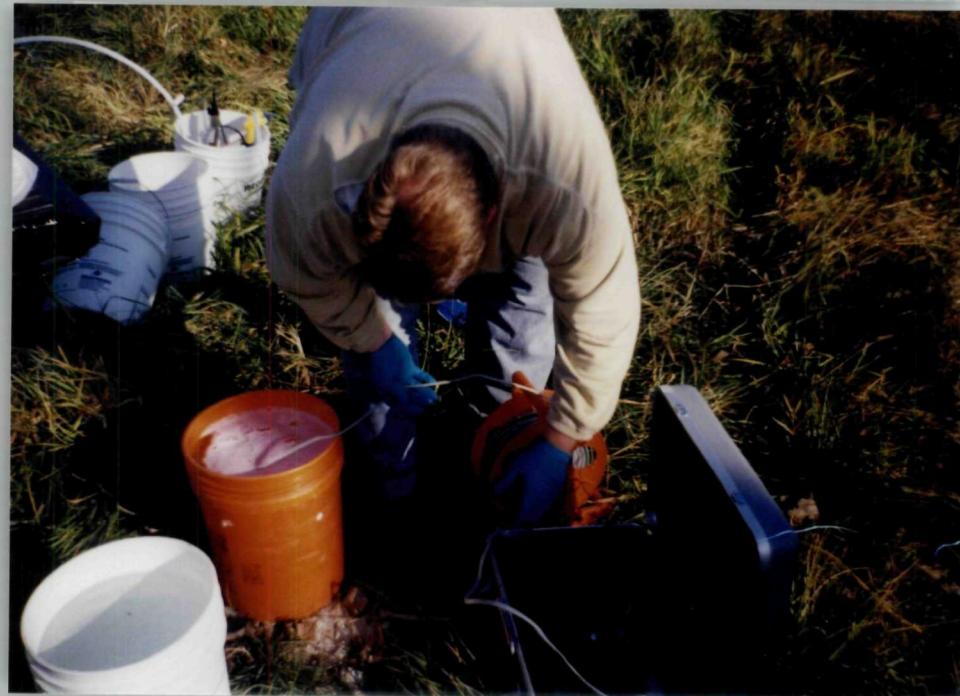
Site: American Chemical Services, Inc.
Proj. #: 46517/46518
Roll: 2 Photo #:16
Date: 11-10-99 Time: 13:55
Photographer: Chad Gailey
Description: Photo facing east at M1S of Rudy
Stein deconning the pump.

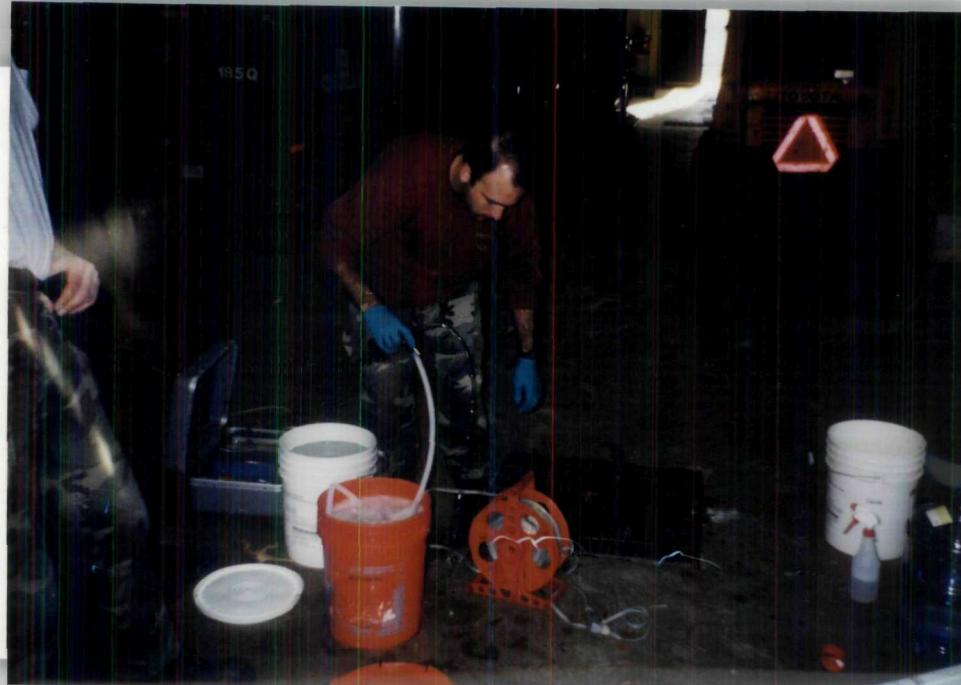
Site: American Chemical Services, Inc.
Proj. #: 46517/46518
Roll: 2 Photo #:17
Date: 11-10-99 Time: 14:15
Photographer: Chad Gailey
Description: Photo facing south at the water treatment Bld. of Chad Smith deconning the pump before pulling a field blank.

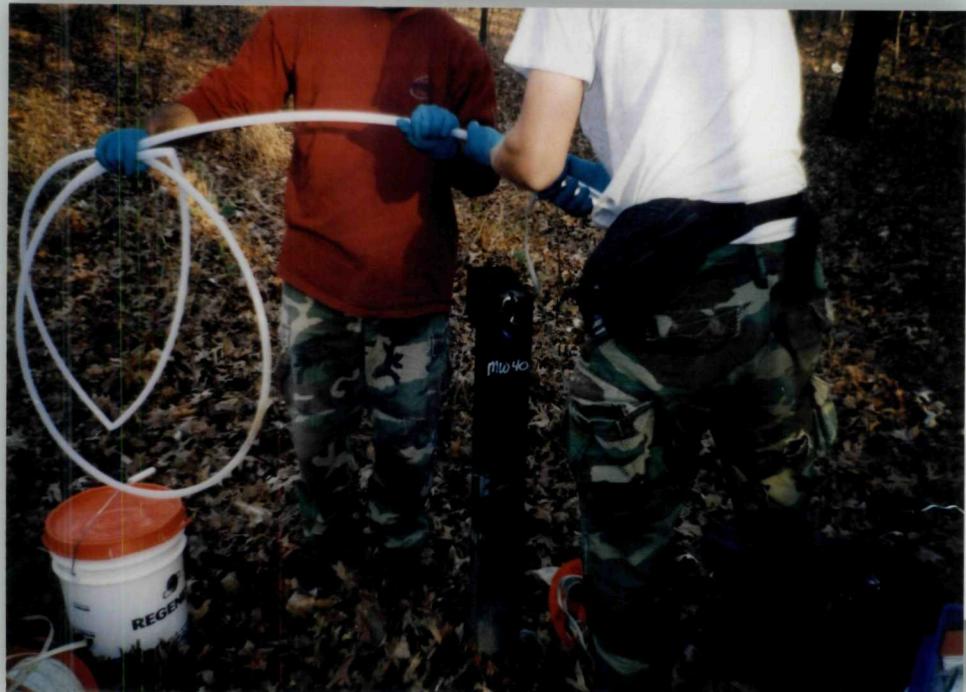
Site: American Chemical Services, Inc.
Proj. #: 46517/46518
Roll: 2 Photo #:19
Date: 11-10-99 Time: 15:10
Photographer: Chad Gailey
Description: Photo facing southeast at MW40 of Chad Smith and Alex Ellwood setting up the pump.

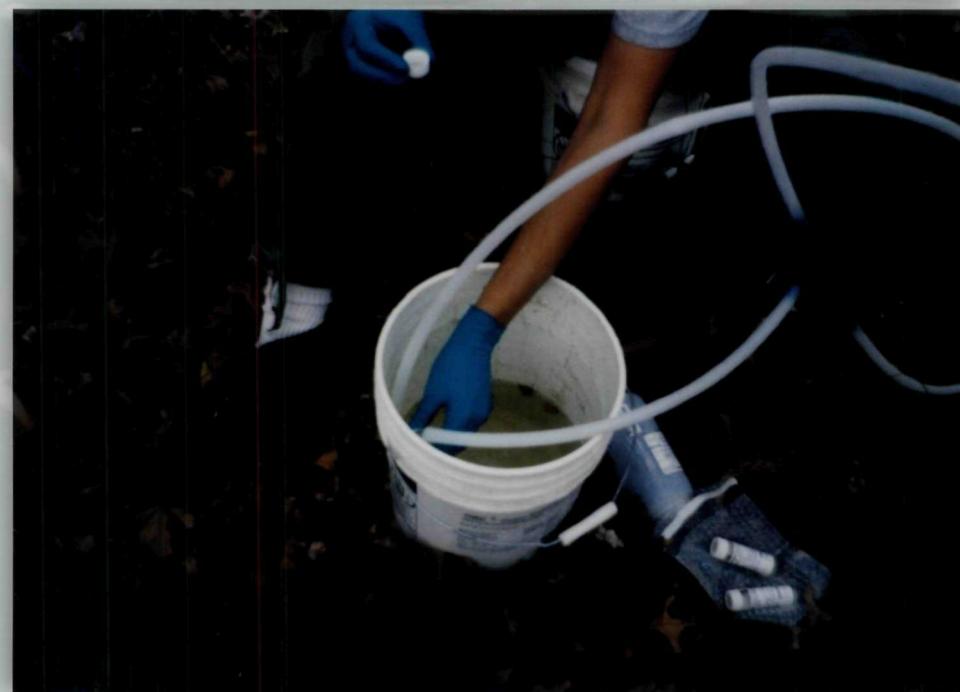
Site: American Chemical Services, Inc.
Proj. #: 46517/46518
Roll: 2 Photo #:20
Date: 11-10-99 Time: 15:43
Photographer: Chad Gailey
Description: Photo facing south at MW40 of Alex Ellwood filling a VOA for indicator parameters.

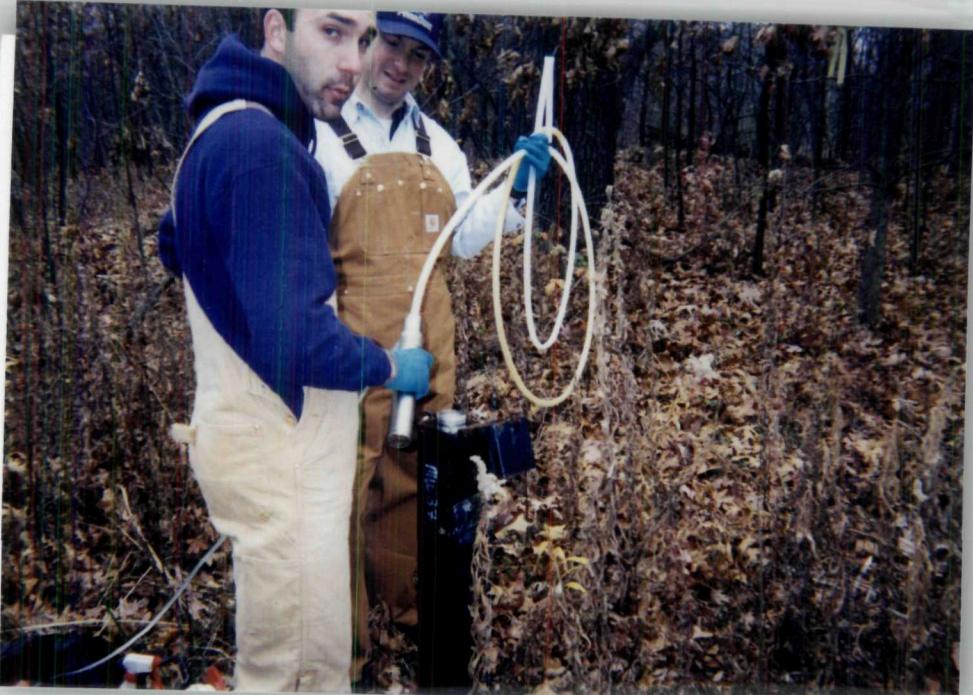
Description: Photo facing east at MW37 of
Lonny Boning and Chad Smith
installing the pump down well.

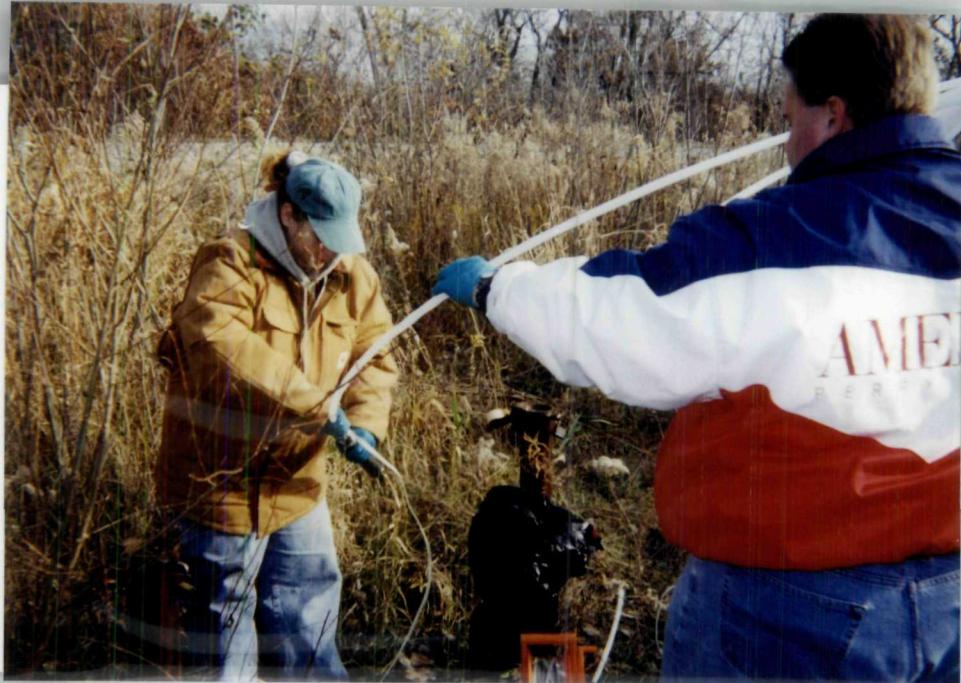
Description: Photo facing east of Dawn
Dougher and Rudy Stein pulling
the sampling pump out of the
MW33.

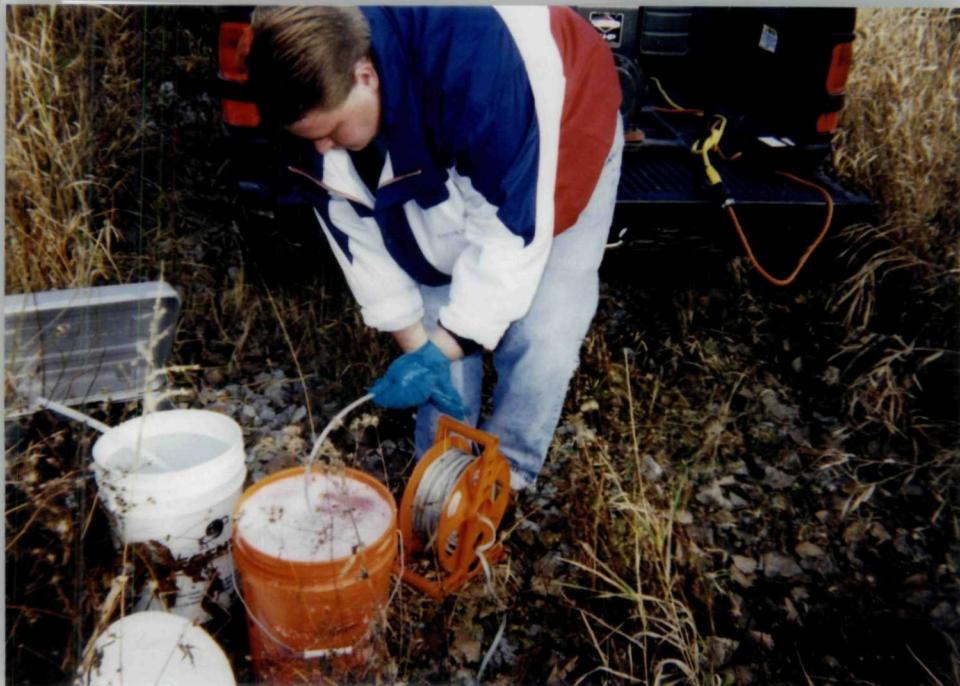
Site: American Chemical Services, Inc.
Proj. #: 46517/46518
Roll: 3 Photo #:3
Date: 11-11-99 Time: 09:20
Photographer: Chad Gailey
Description: Photo facing north at well nest
MW33 and MW30 of Rudy Stein
deconning the pump and
equipment.

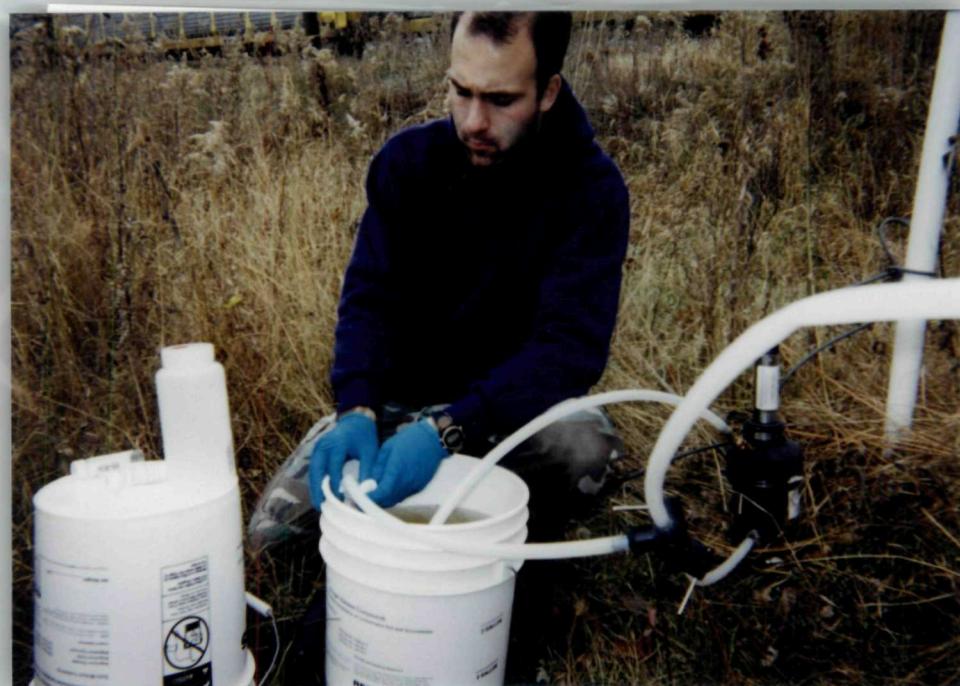
Site: American Chemical Services, Inc.
Proj. #: 46517/46518
Roll: 3 Photo #:4
Date: 11-11-99 Time: 10:36
Photographer: Chad Gailey
Description: Photo facing southwest at MW24
of Chad Smith filling a VOA for
indicator parameter.

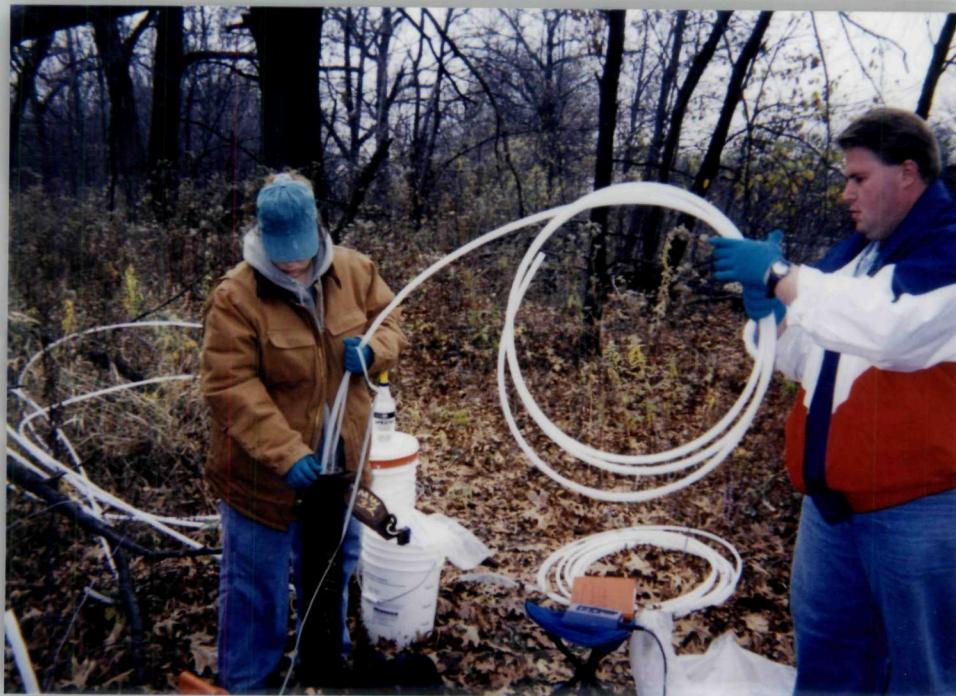
BVSPC noted problems with the tubing used to sample the groundwater. Numerous kinks were created installing and extracting the pump during sampling that hindered groundwater flow. Proper low flow sampling procedures were not available upon arriving on site by Montgomery Watson, nor were the proper well logs as needed for reference.

Site: American Chemical Services, Inc.
Proj. #: 46517/46518
Roll: 3 Photo #:8
Date: 11-11-99 Time: 14:30
Photographer: Chad Gailey
Description: Photo facing southwest at MW32
of Rudy Stein and Dawn Dougher
installing the pump and new
tubing down well.

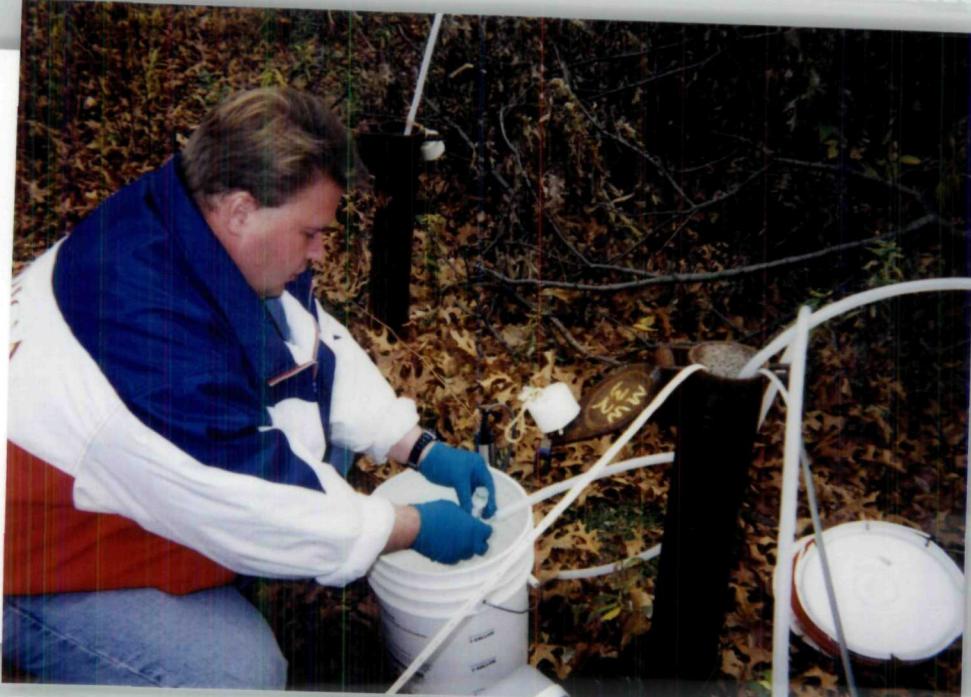
Site: American Chemical Services, Inc.
Proj. #: 46517/46518
Roll: 3 Photo #:9
Date: 11-11-99 Time: 15:00
Photographer: Chad Gailey
Description: Photo facing east at MW32 of
Rudy Stein filling a VOA for
indicator parameters.

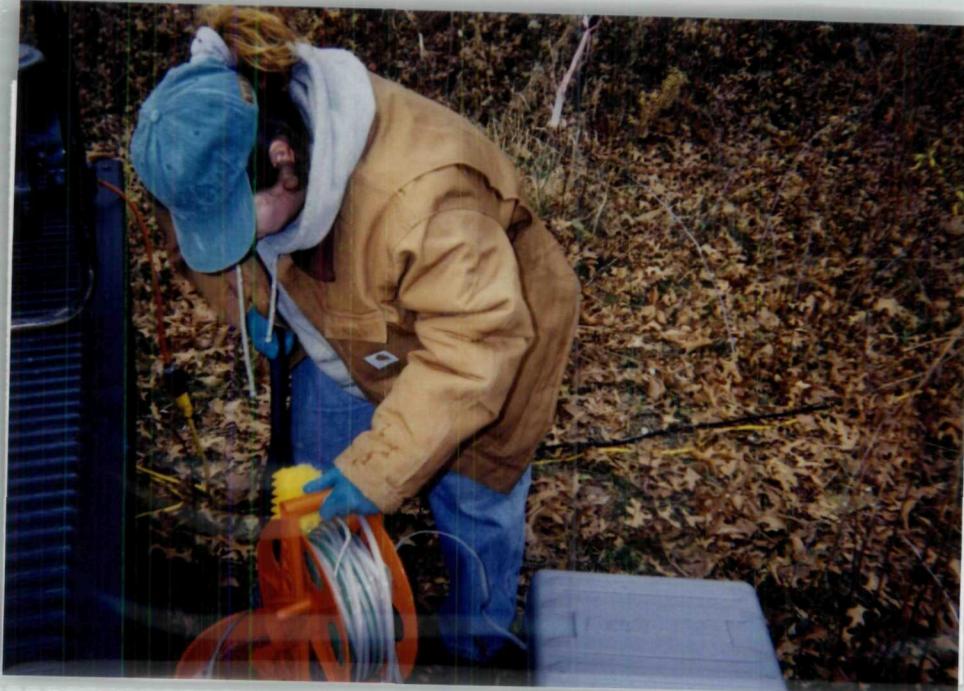
Site: American Chemical Services, Inc.
Proj. #: 46517/46518
Roll: 3 Photo #:10
Date: 11-11-99 Time: 15:20
Photographer: Chad Gailey
Description: Photo facing north at MW32 of
Dawn Dougher deconning
sampling equipment.

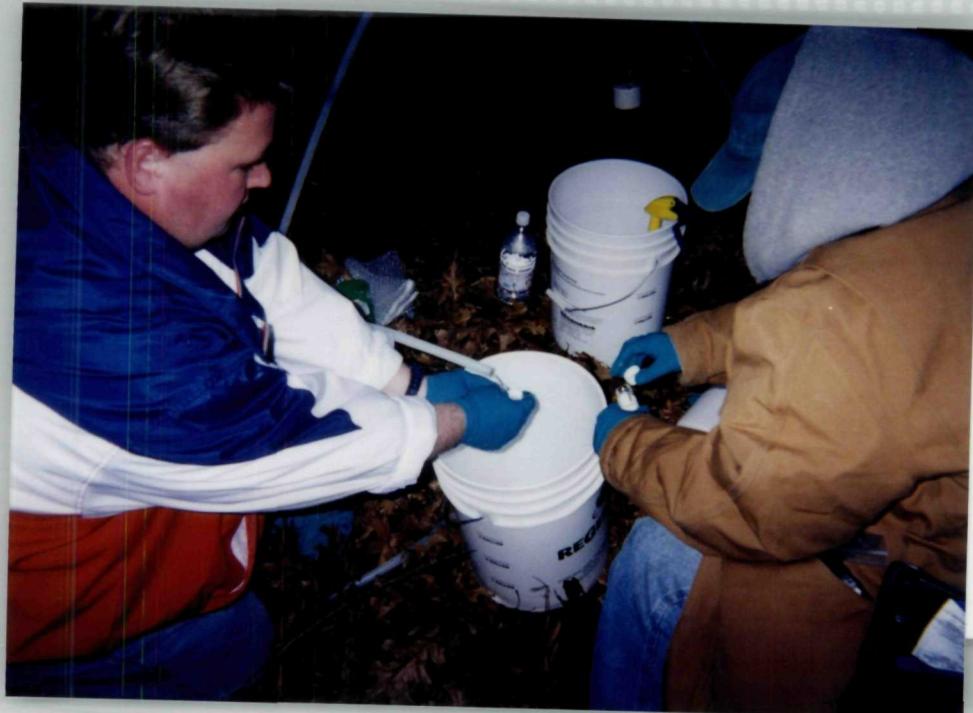
Site: American Chemical Services, Inc.
Proj. #: 46517/46518
Roll: 3 Photo #:11
Date: 11-11-99 Time: 16:20
Photographer: Chad Gailey
Description: Photo facing south at MW31 of
Rudy Stein and Dawn Dougher
filling sample bottles for indicator
parameters.

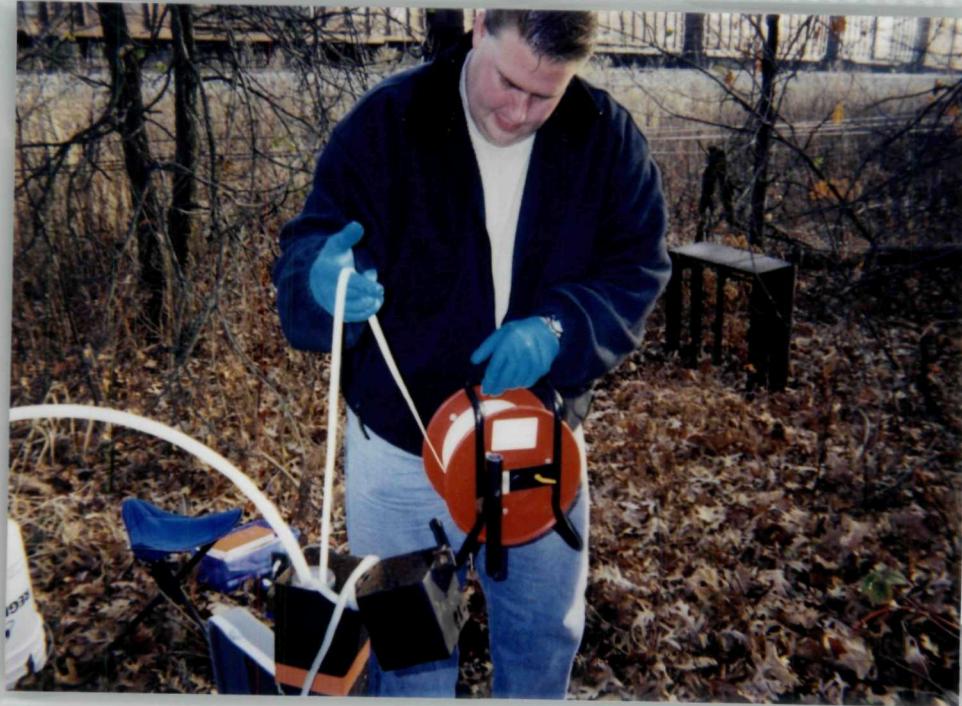
Site: American Chemical Services, Inc.
Proj. #: 46517/46518
Roll: 3 Photo #:12
Date: 11-12-99 Time: 08:02
Photographer: Chad Gailey
Description: Photo facing north at MW49 of
Rudy Stein taking depth to water
measurement.

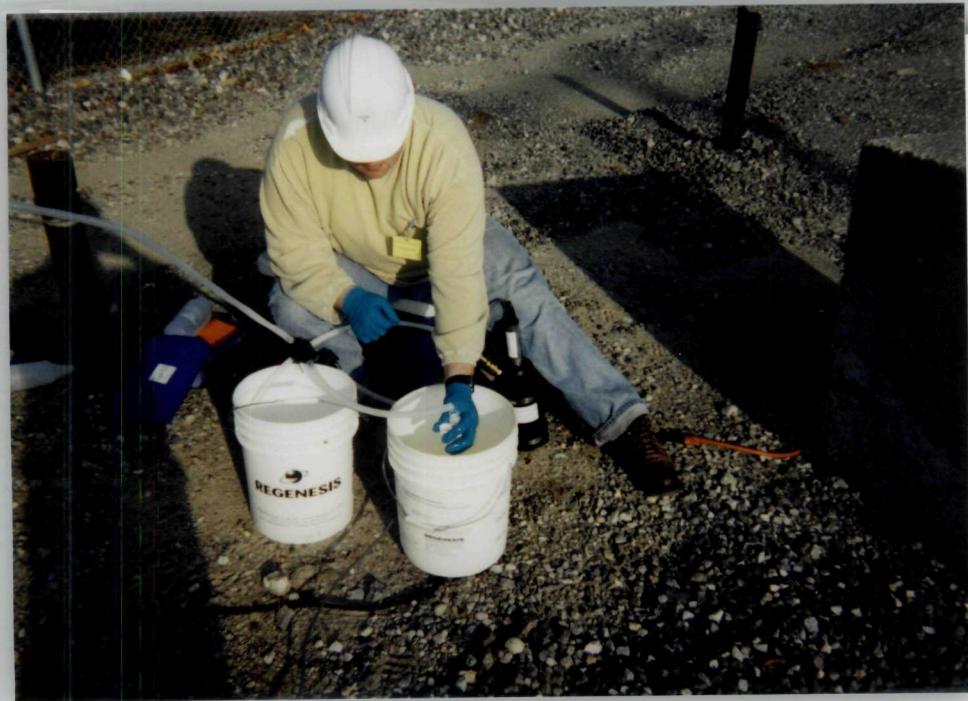
Site: American Chemical Services, Inc.
Proj. #: 46517/46518
Roll: 3 Photo #:15
Date: 11-12-99 Time: 09:15
Photographer: Chad Gailey
Description: Photo facing northwest at ATM4D of Rudy Stein filling a VOA for indicator parameters.

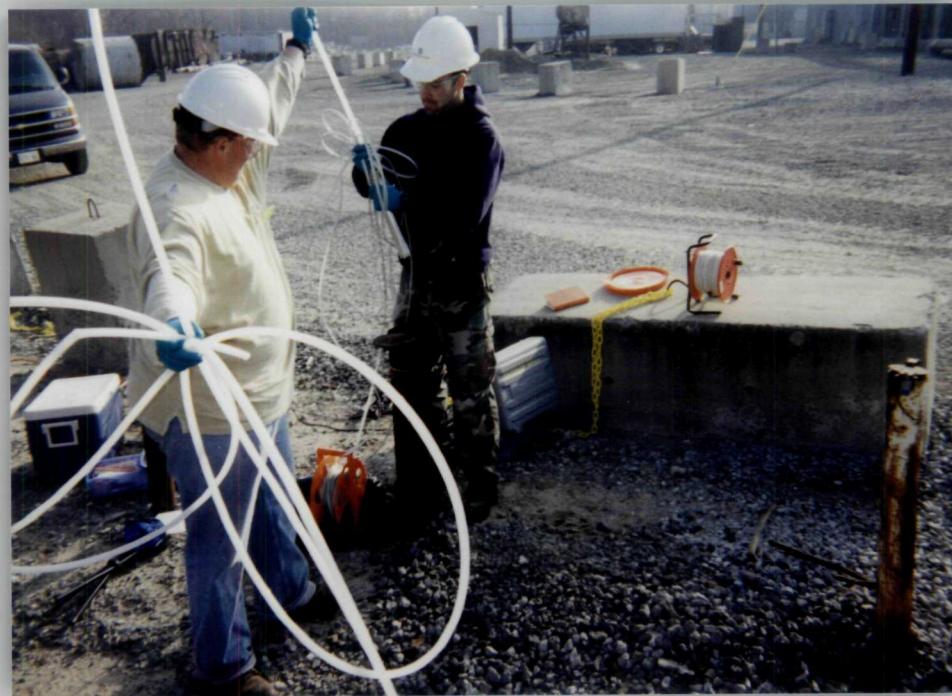
Site: American Chemical Services, Inc.
Proj. #: 46517/46518
Roll: 3 Photo #:16
Date: 11-12-99 Time: 09:25
Photographer: Chad Gailey
Description: Photo facing northwest at ATM4D of Rudy Stein and Chad Smith pulling out the pump after sampling.

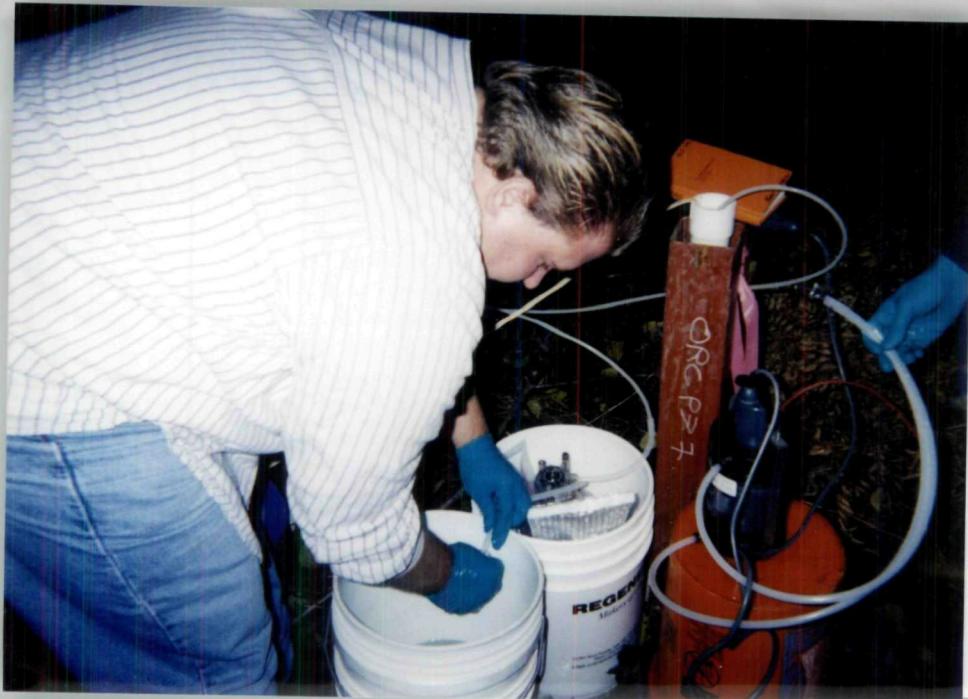
Site: American Chemical Services, Inc.
Proj. #: 46517/46518
Roll: 1 Photo #: 6
Date: 10-13-99 Time: 09:01
Photographer: Chad Gailey
Description: Photo facing north at PZ7 of
Rudy Stein Filling a VOA for
ORC sampling.
